# Manhole Inspection Summary

Manhole # **S39S\_\_048MH**

Insp Date: **3/13/08 10:25 AM**

**Location** Address: **1351 jackson st**

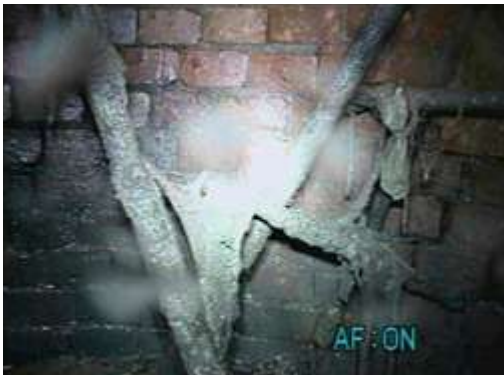
misc

bench debris

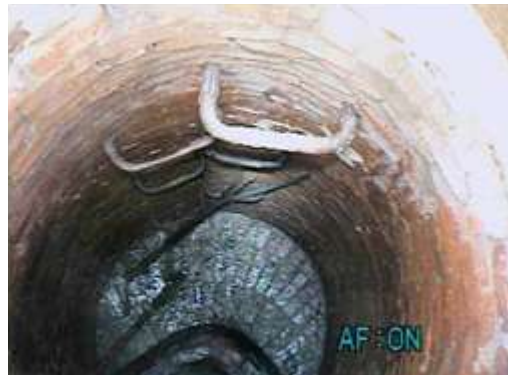
Defect 2

**Steps** Count: **6** Missing: **0** ☒ **Corroded**

corroded steps

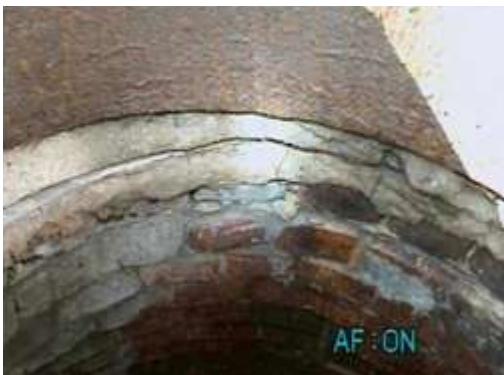
Defect 1

Condition: ☐ Sound ☒ **Cracked** ☐ Root Intrusion ☒ **Loose Brick** ☐ Deteriorated

chimney loose bricks, cracked/adjustment

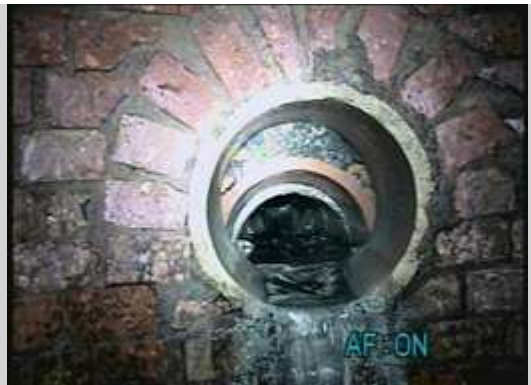
9 O'Clock Inflow

offset pipe joint. failed drop connection
